***HERITAGE HARBOR
COMMUNITY DEVELOPMENT DISTRICT***

Capital Projects Workshop

Proposed Ten-Year Capital Expenditures - Golf Course

Golf Course Capital Improvement Evaluation

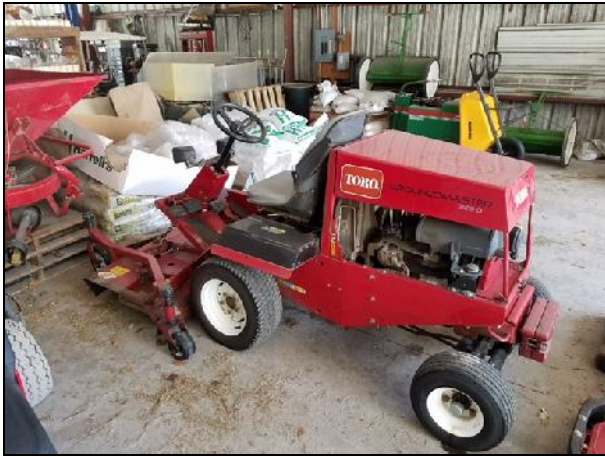
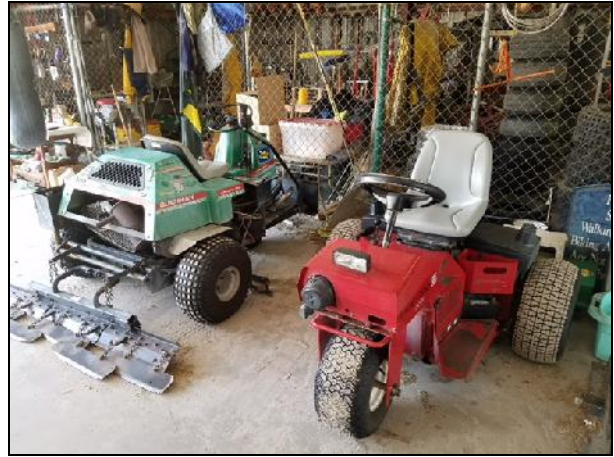
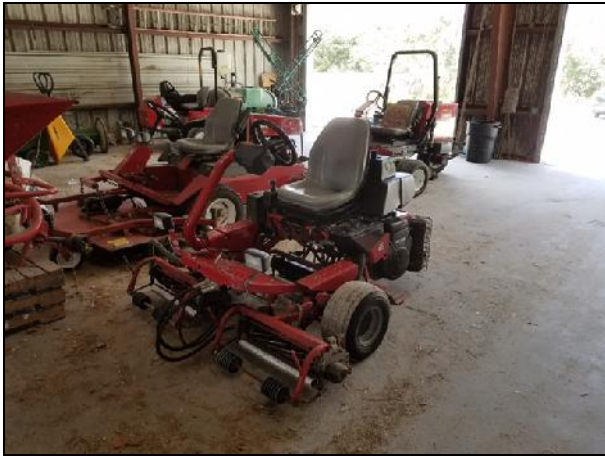
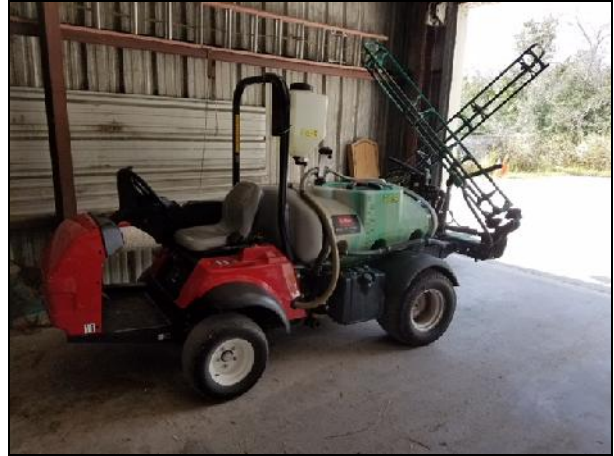
Much of the equipment is beyond its useful life (with the exception of the leased equipment)

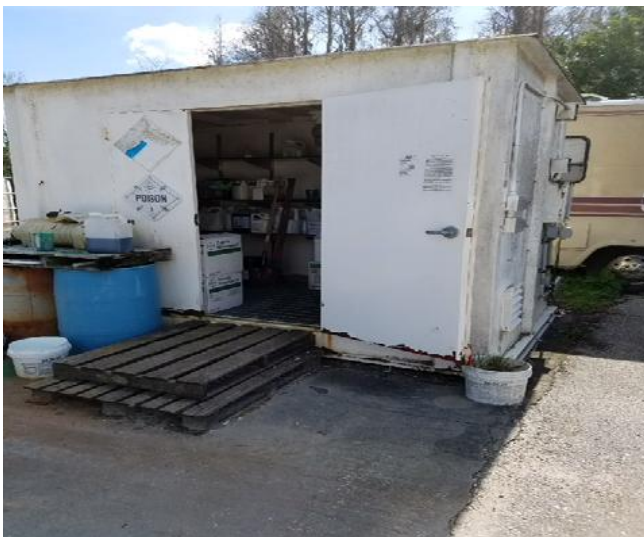
The chemical storage building is 20 years old and has quite a bit of corrosion; there is no current risk of environmental contamination

Golf maintenance chemical building	To replace current building (rusting out)	\$12,500	0	0	12,500	0	0	0	0	0	0	0
Fencing on hole 4, separating adjoining community	Upgrade 698' of decorative fencing, on hole 4 to higher grade material for enhanced longevity and security	\$20,880	20,880	0	0	0	0	0	0	0	0	0
pump station motor/pump replacements	To replace 20+ year old 75hp motors	\$37,500	0	12,500	12,500	12,500	0	0	0	0	0	0
Drainage work on hole 4 near retaining wall behind green	Allegedly caused when retaining wall was built, standing water floods the area and breeds mosquitos	\$10,000	10,000	0	0	0	0	0	0	0	0	0
Drainage catch basin extensions, backfill, sod	safety issue for carts, mowing equipment and foot traffic, many are a foot or more below grade, 30@\$300 each	\$9,000	9,000	0	0	0	0	0	0	0	0	0
SUBTOTAL		\$1,261,751	\$227,631	\$182,300	\$262,670	\$207,550	\$20,000	\$63,000	\$74,000	\$75,800	\$113,800	\$35,000

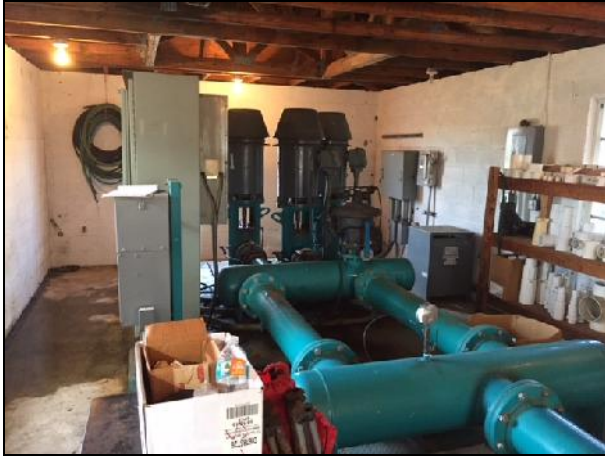
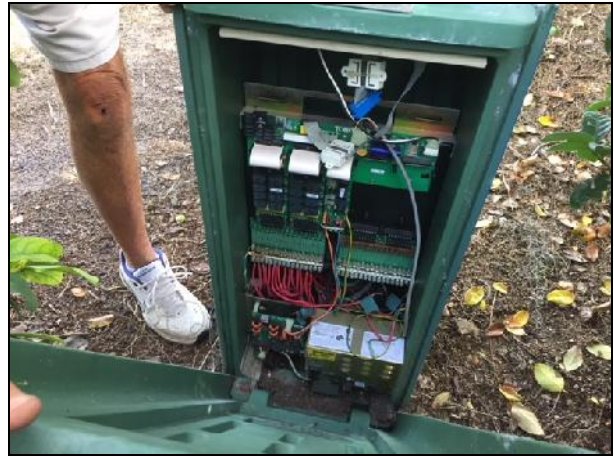
The irrigation pump station and system components are nearly 20-years old. The main control unit is obsolete and no longer functioning. The balance of the system, including field controllers, valves, pipe and heads, are otherwise in reasonably good condition.

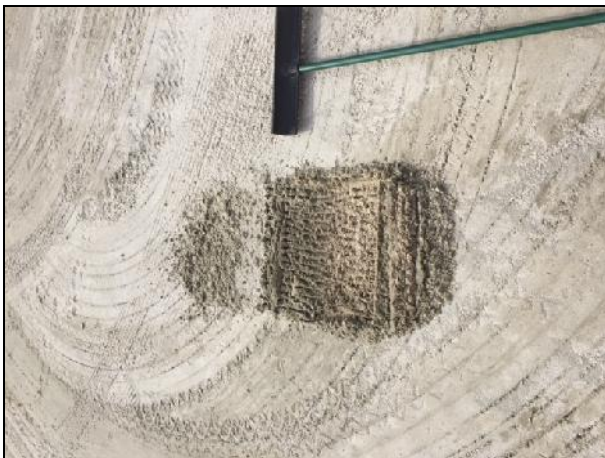
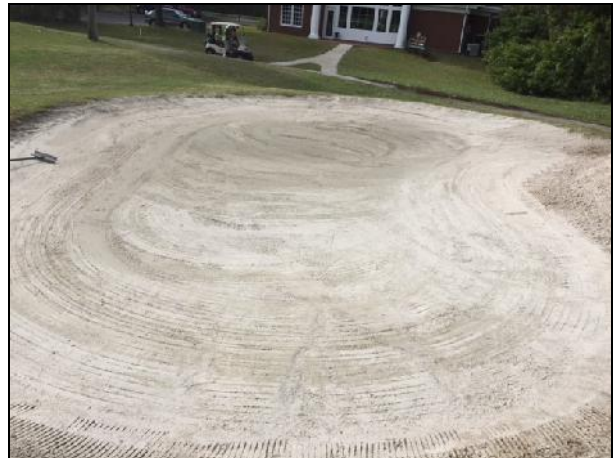
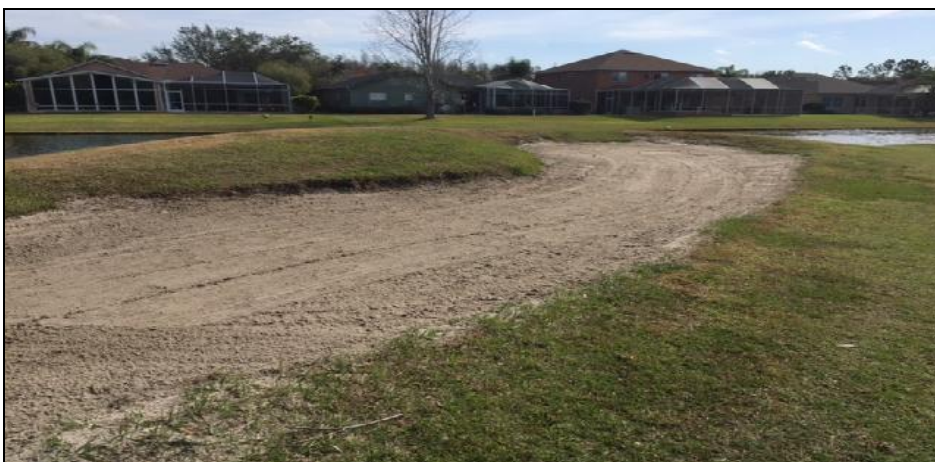
The sand bunkers are all in need of excavation and upgrading to modern materials; and are severely compacted. Upgrading and enhancing the greenside bunkers will greatly improve course playability, conditions, and golfer satisfaction and retention

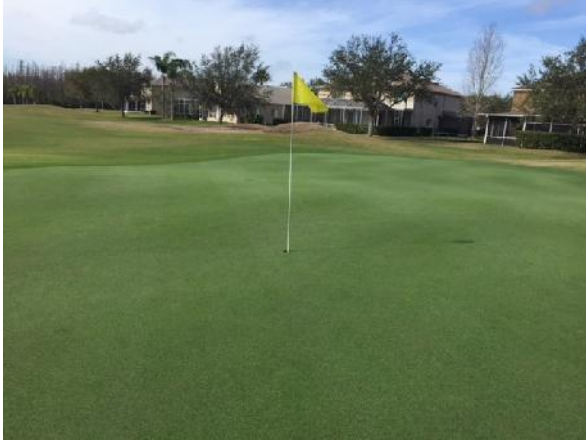
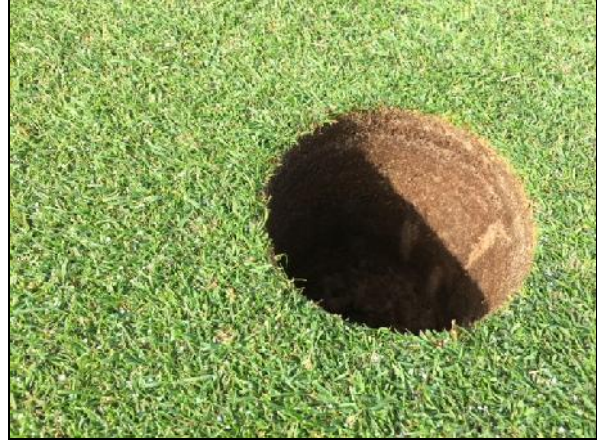
The greens are in excellent condition and the soil profiles indicate very good agronomy practices (aeration and sand topdressing), despite being nearly 20 years old

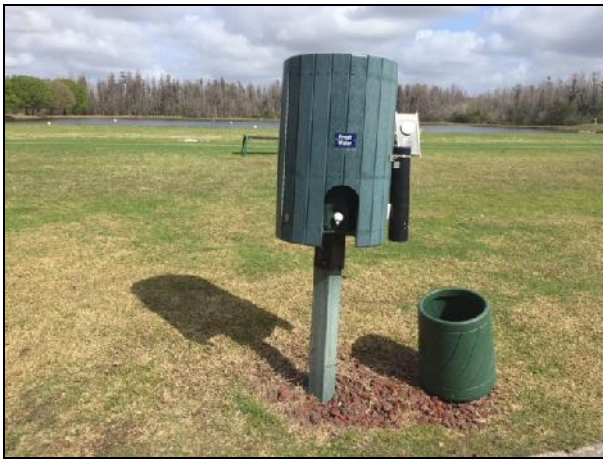
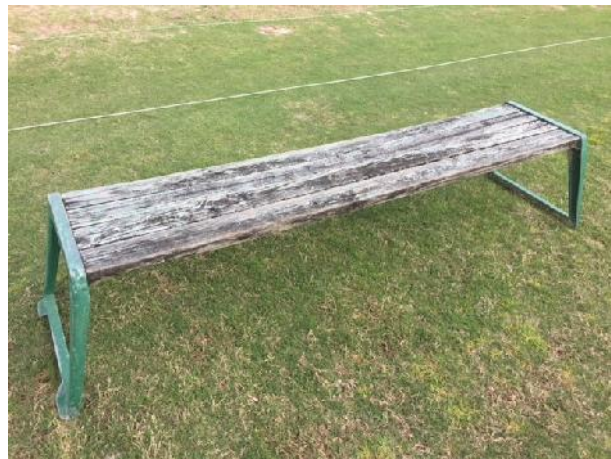
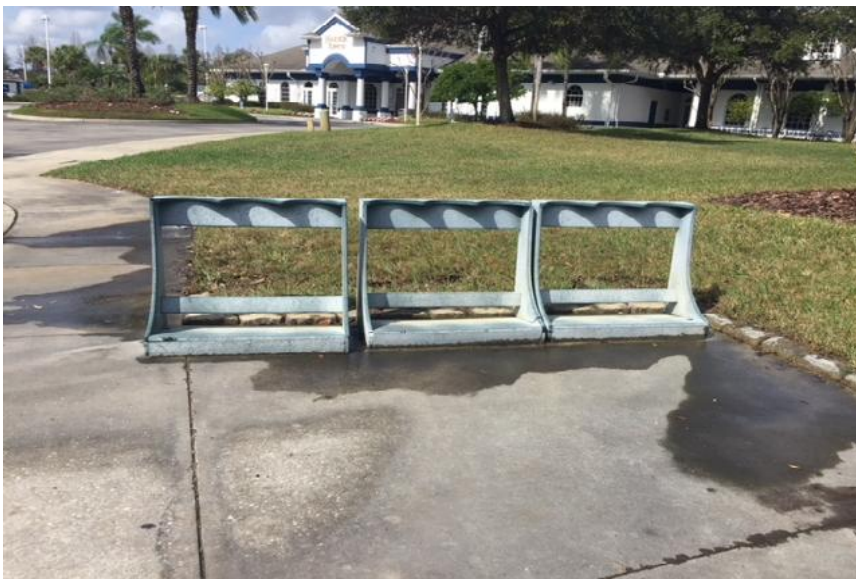
Replacing these amenities will add to the overall property aesthetics and the quality of the guest experience

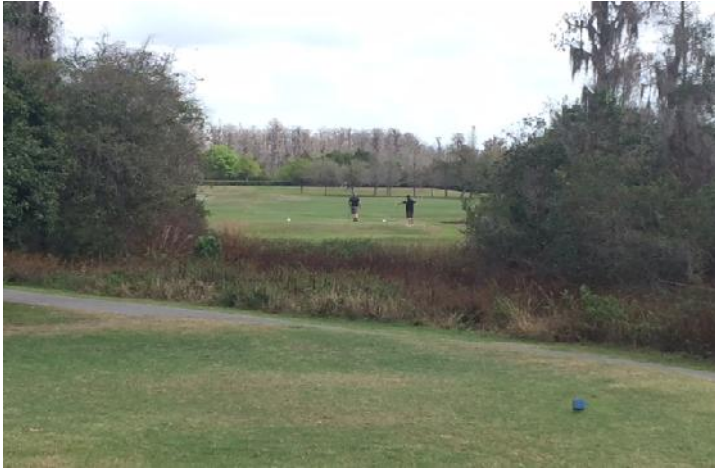
There are several tee areas that need overgrowth clearing for improved playability

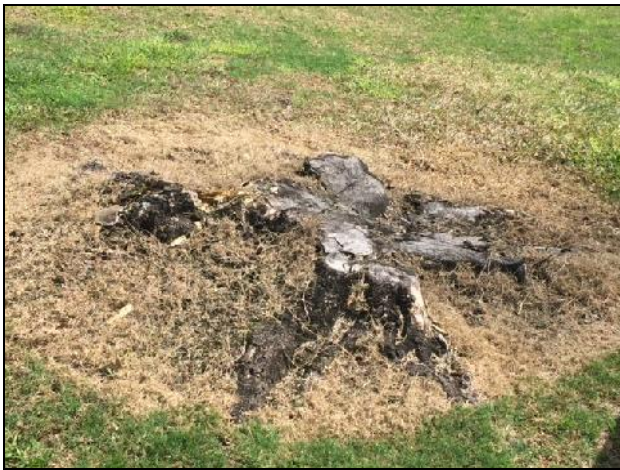
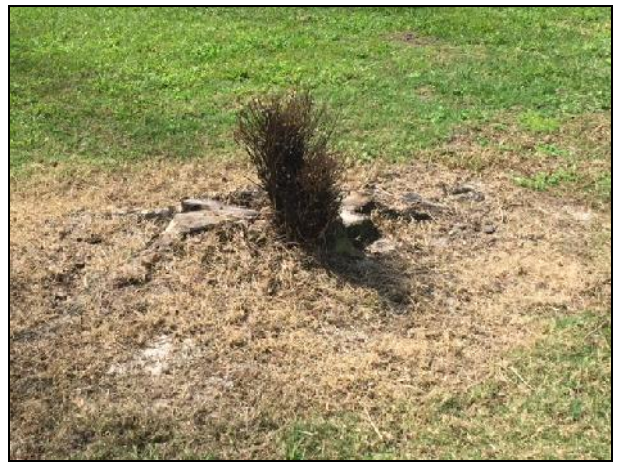
The addition of a stump grinder would eliminate unsafe and unsightly tree stumps

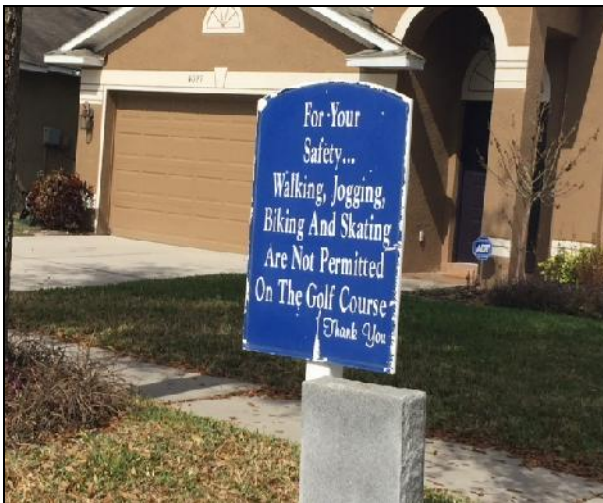
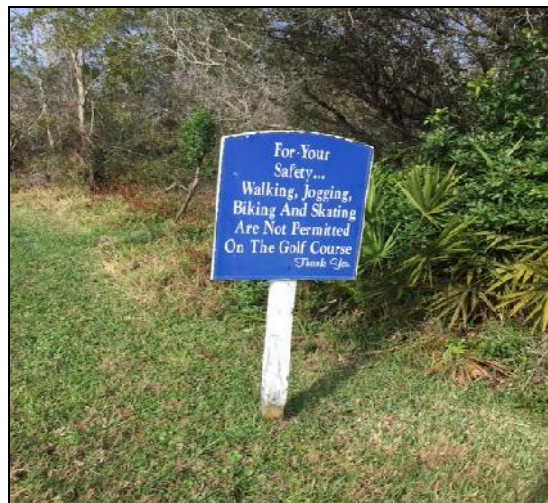
Upgrading the quality and composition of the course signage will enhance property aesthetics and sign longevity

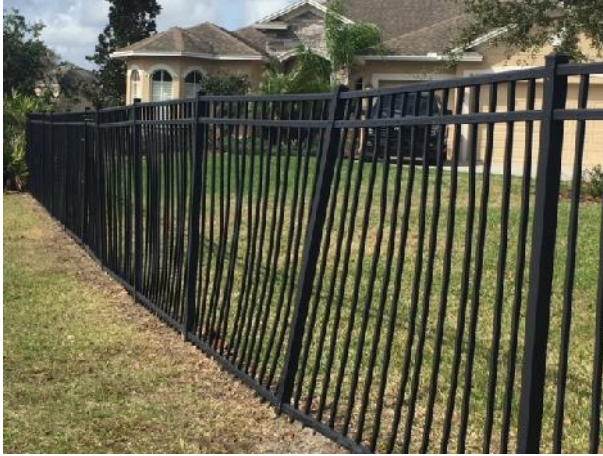
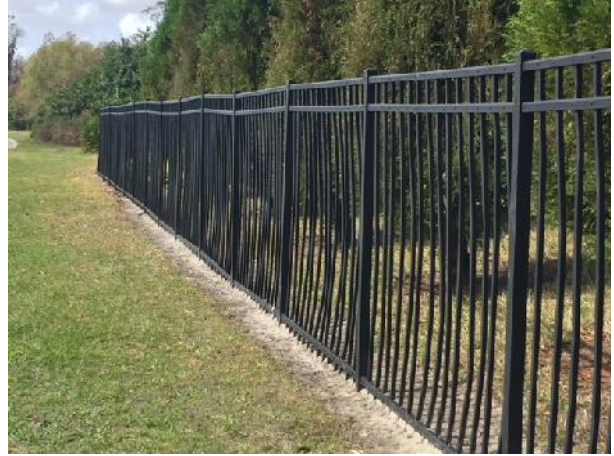
The damaged fence on hole 4 will need to be upgraded to a more durable material at some point, for aesthetic and security reasons

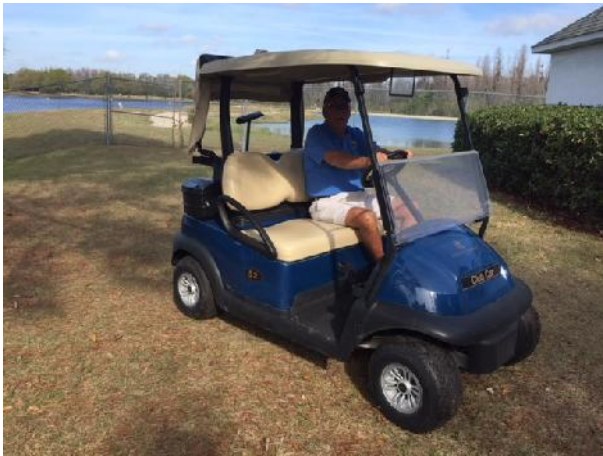
The golf carts are in very good condition and are in year two of a three year lease with Club Car. The club could use an additional 10 carts in season (they currently have 70 carts) since they routinely run out of carts and lose as many as 20 to 30 rounds per day in season

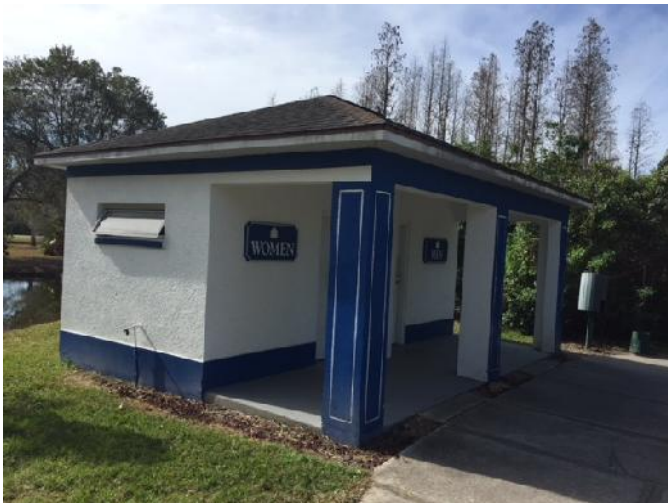
The golf course restrooms are in reasonably good condition and are well-maintained

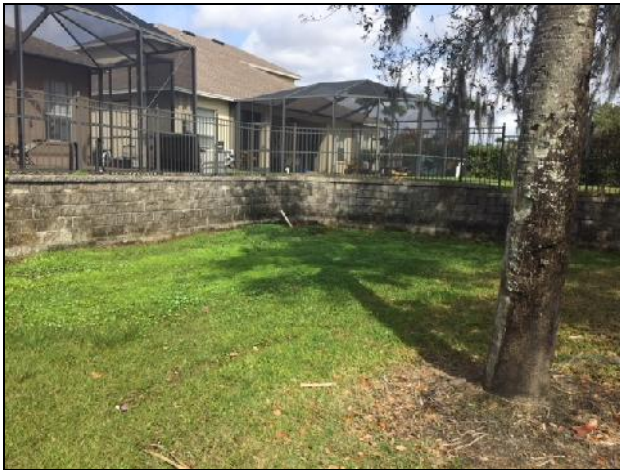
This is the area behind #4 green that needs drainage enhancements

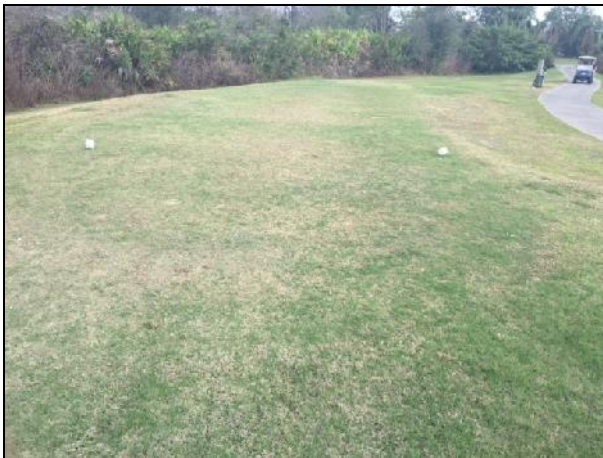
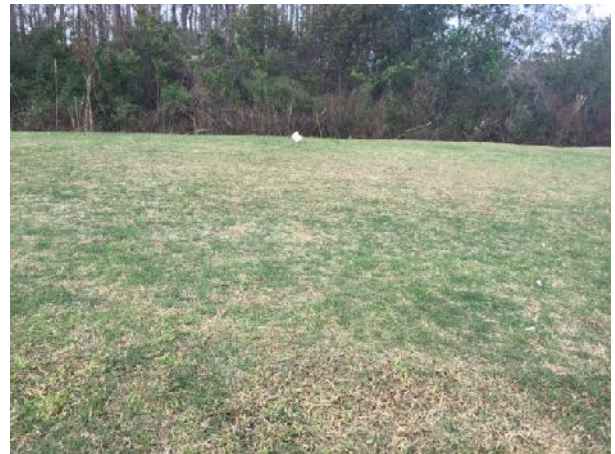
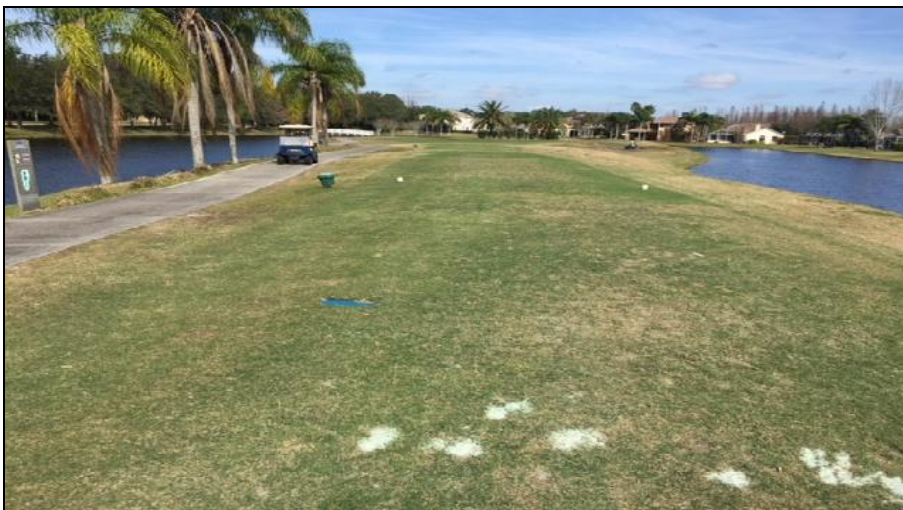
Some of the ‘crowned’ par three tee boxes in need of leveling and expansion to enhance playability and turf quality

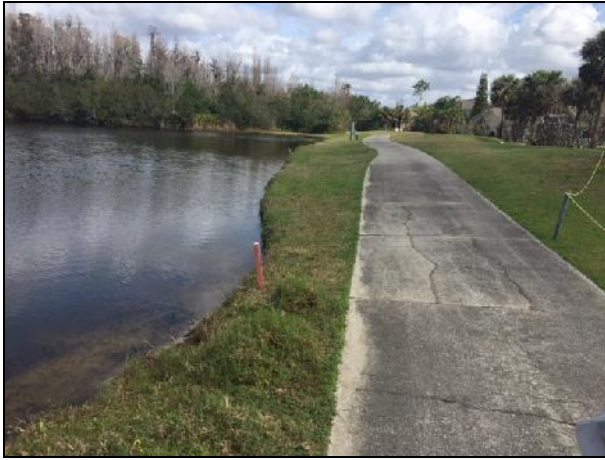
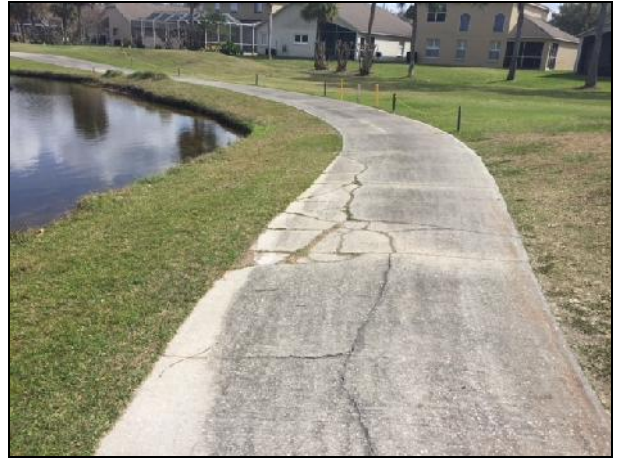
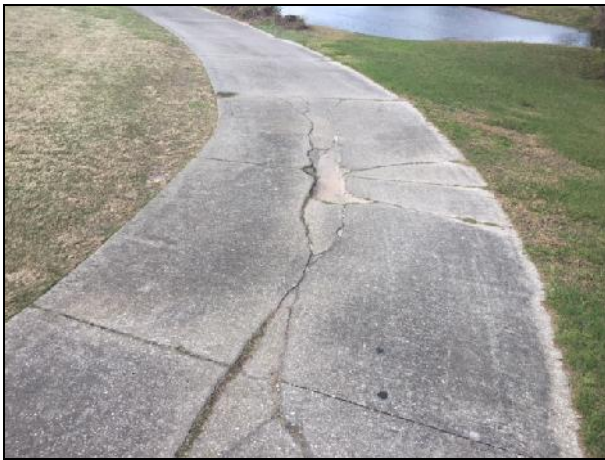
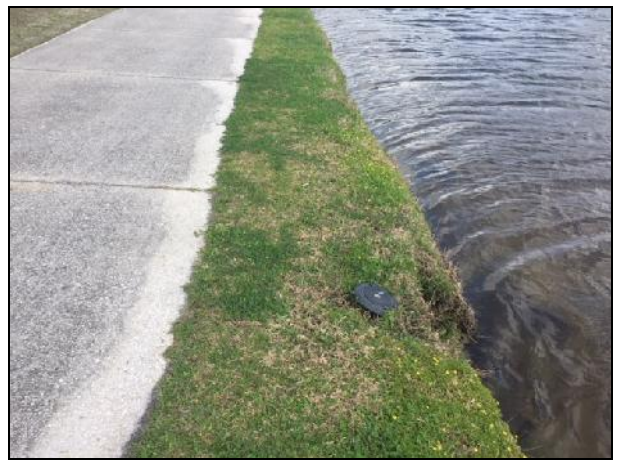
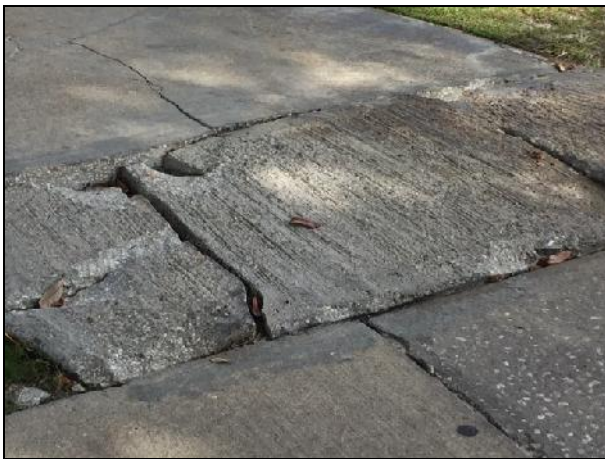
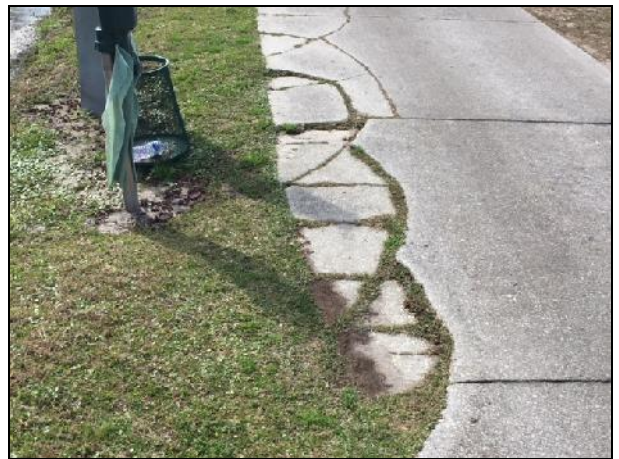
Lake bank erosion and cart path damage

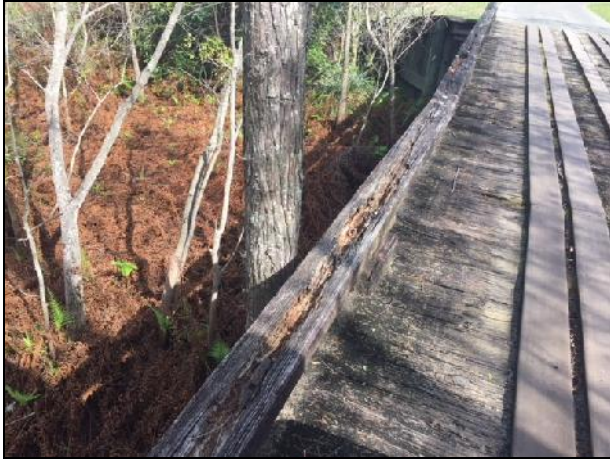
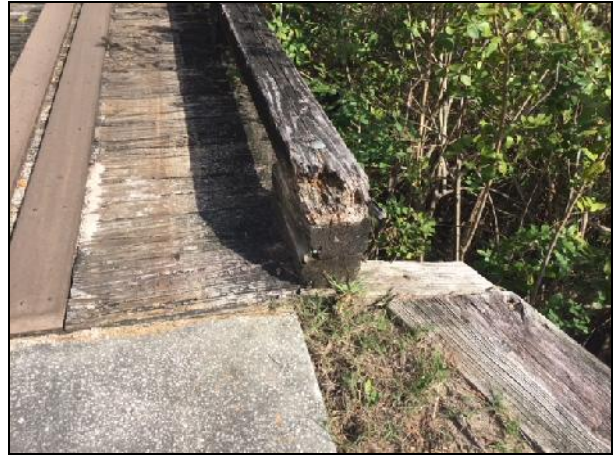
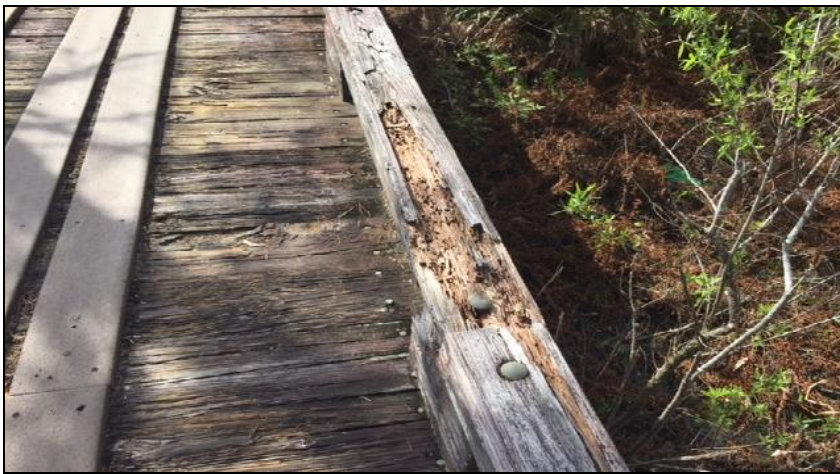
Representative photos of bridge rail and decking wear and tear. The bridge infrastructure (footers) appears to be in sound condition, the superintendent has installed composite runners to extend the life of the decking for now but conditions will continue to deteriorate

Golf course bridges	Upgrade and enhance all bridge decking and railings with marine-grade material, total of 741 linear feet at \$2.50 per lf	\$1,853	1,853	0	0	0	0	0	0	0	0	0
Cart path enhancements	Excavate and enhance 50% of the 5,652 linear feet of cart paths to maximize maneuverability	\$110,340	30,170	0	30,170	0	0	25,000	0	0	25,000	0
Golf course maintenance entry road and paved area around building	Approximately 3/10 mile of 20' wide road plus 15,000 sf of pad at \$3.75 psf	\$175,050	0	0	0	175,050	0	0	0	0	0	0

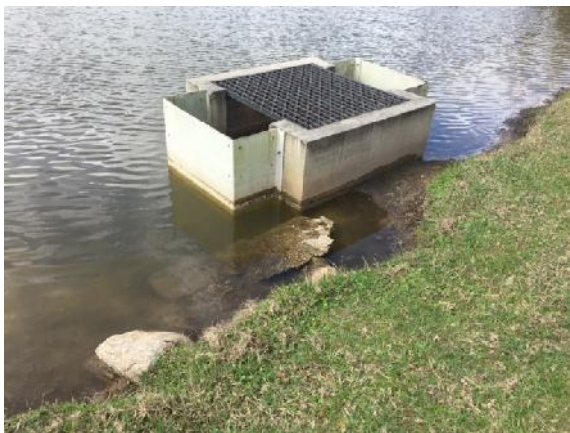
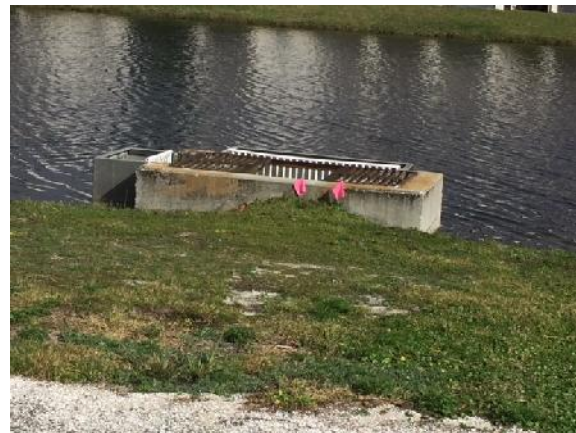
The lake system and culverts appear to be in good condition but should probably be inspected by an engineer

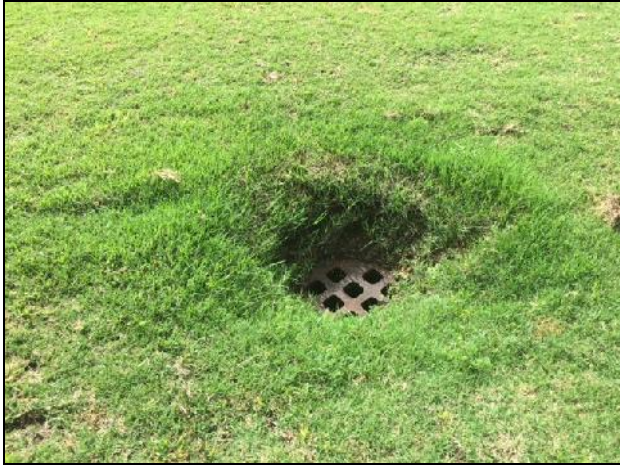
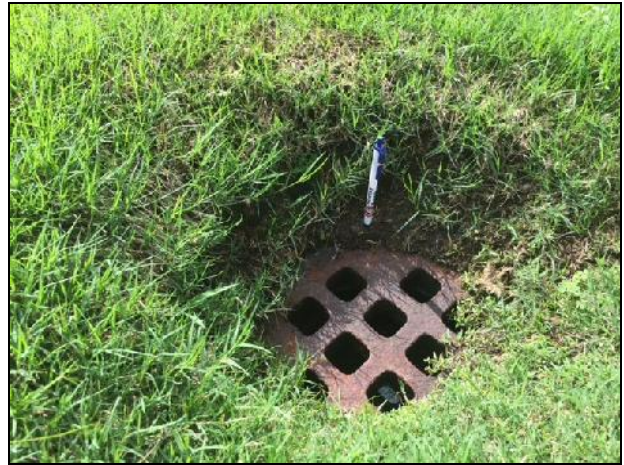
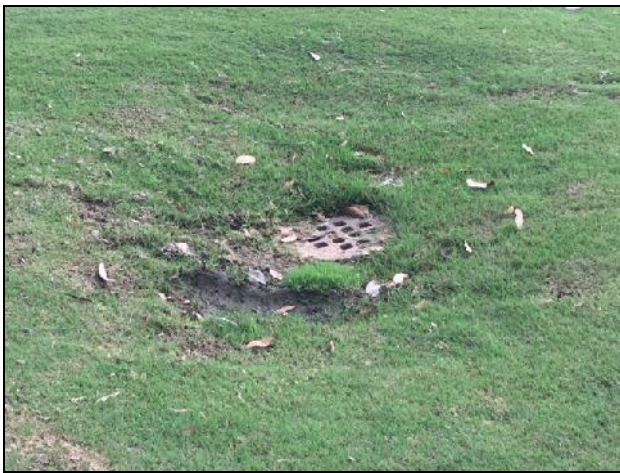
These drainage catch basins need to be extended and raised to ground level to prevent injury and cart/equipment damage

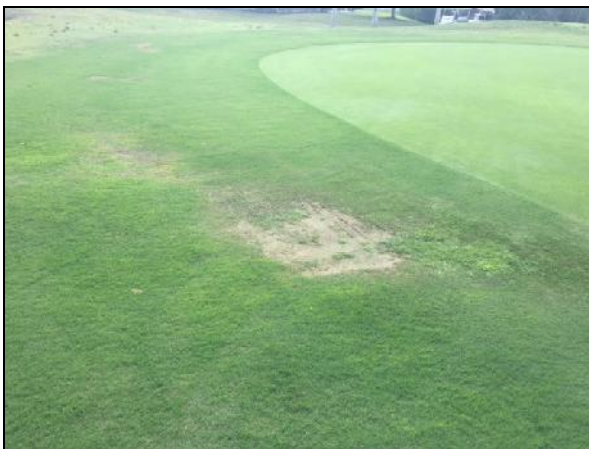
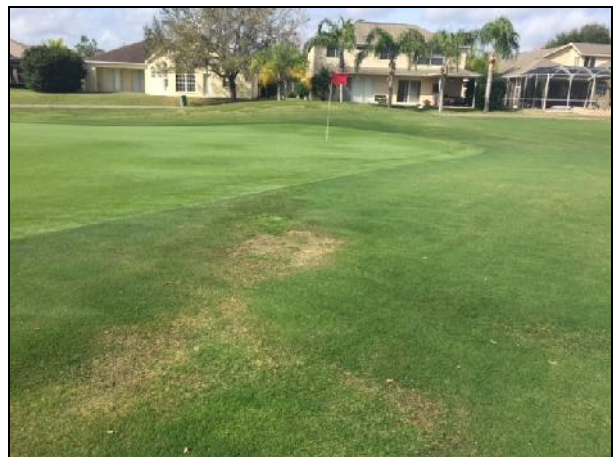
The 13th green complex needs to be raised and new drainage installed to improve playability and turf quality

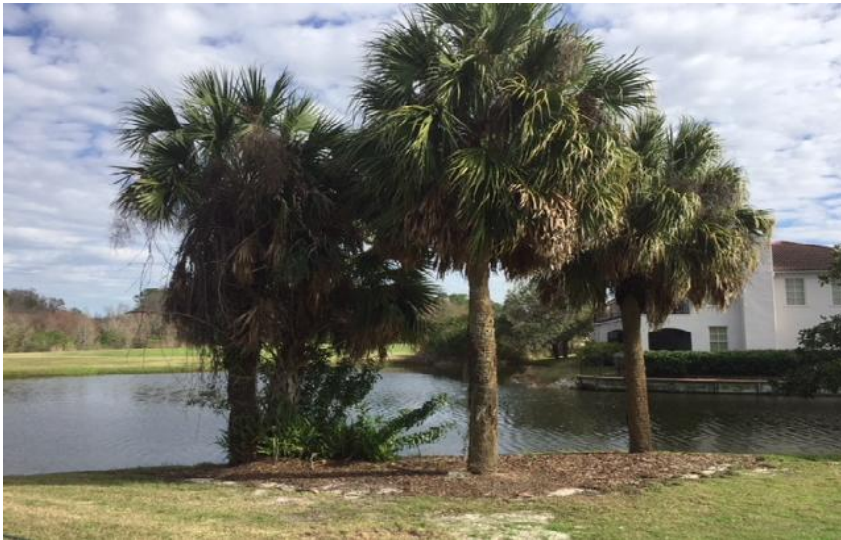
The entire golf course is in need of tree pruning; accommodation should be made in the course operating budget to maintain the trees in aesthetic and safe condition
